INSPECTION ADDRESS: 123 Main Street

DATE OF INSPECTION: May 3, 2011

GENERAL BUILDING DESCRIPTION

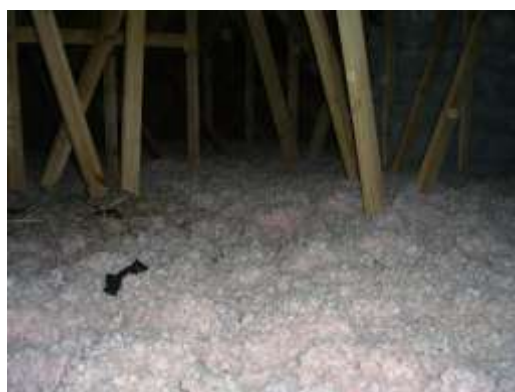
We gained partial access to the attic through the ceiling hatch at the 2nd floor guest suite bedroom closet. A general view of the attic is shown in the picture below. The triangulated wood trusses and plywood sheathing were in serviceable condition, where visible and accessible. Insulation is blown/loose fiberglass material that appears to have an insulation value of approximately R30. The attic is ventilated through a series of large static vents and soffit vents. There was no evidence of leaks or seepage noted during our inspection. Wall insulation is concealed and therefore, could not be confirmed.

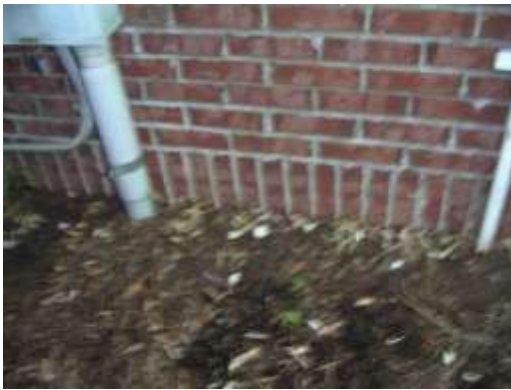
Picture 4

1. We noted that the grounds and ground cover extend above the sill plate level throughout various portions of the residence (example picture 4). This is a potential source for moisture damage/termite infestation and we recommend modifications to eliminate this condition.

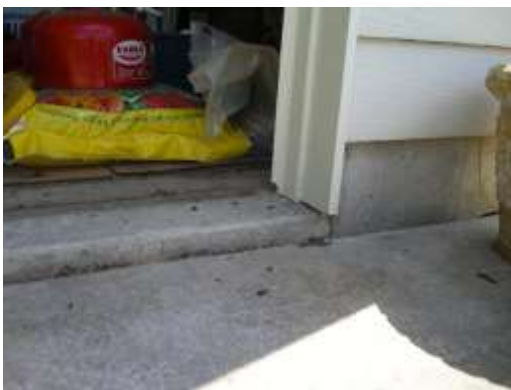
Picture 14

2. We identified slight separation to the leader pipe connection south of the front entry.
3. We identified an offset/trip hazard where the driveway abuts the garage (picture 14). We identified cracked and broken sections, surface spalling and patched sections of the driveway and recommend close monitoring for additional patching.

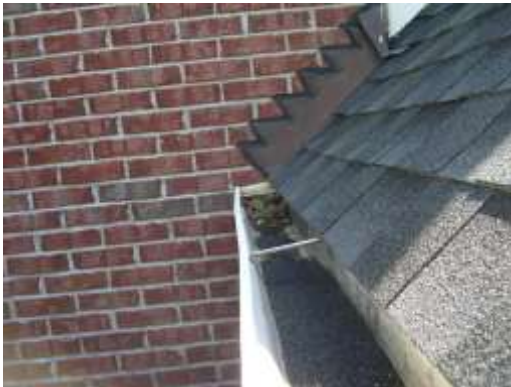
Picture 7

4. We noted vegetation to be in close proximity to building surfaces and recommend it be trimmed now and on a routine basis.
5. The photo cell mechanisms are installed slightly higher than 6 inches above the garage floor slab and we recommend they be lowered to a more appropriate height.
6. We noted that some GFCI devices in the garage are redundant.
7. Portions of the attached aluminum gutters are in need of cleaning and slope adjustments (picture 7).

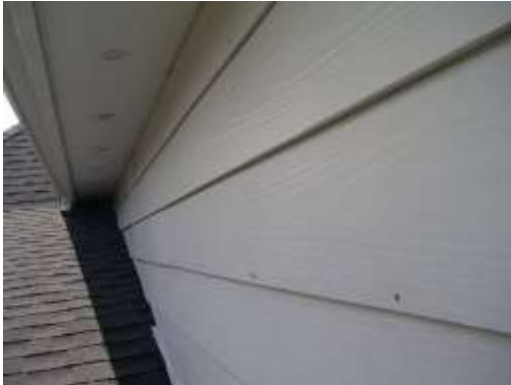
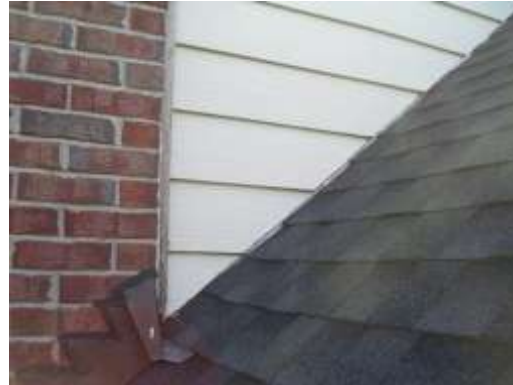
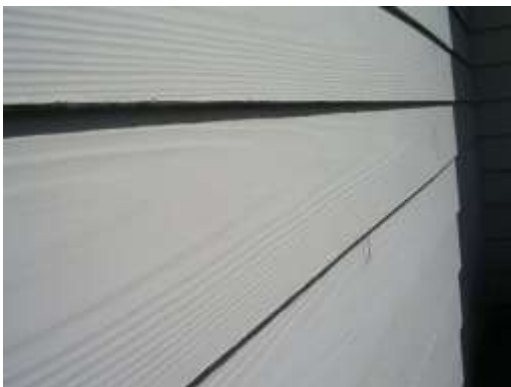
9. We identified evidence of manufacturer's defect to portions of the siding (example picture 2, 8, 9). We also identified some damage to the composite siding adjacent to the newer steps landing at the rear exposure of the residence (picture 11). This material has previously been involved in a class action law suit. To the best of our knowledge all monies have been disbursed. You may wish to inquire of the current homeowner regarding any claims.

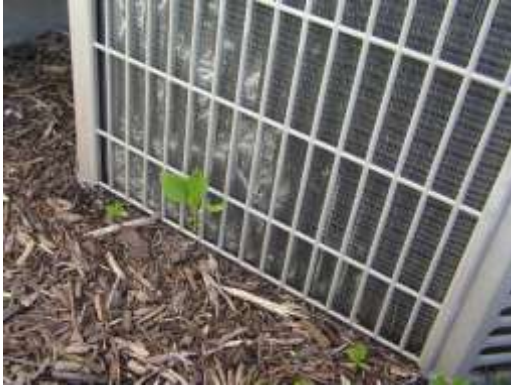
Picture 10

13. We noted damaged cooling fins and soils build-up at the York brand condensing unit (picture 10). We recommend servicing and maintenance as needed.

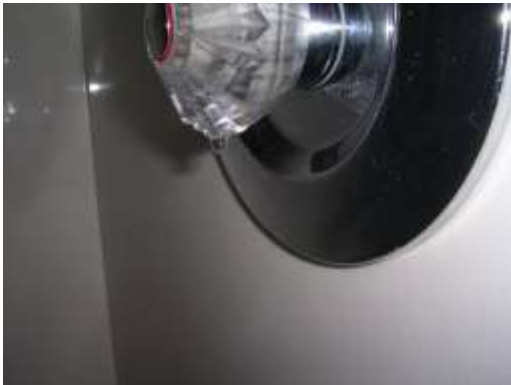
Picture 17

15. We noted a slow sink drain at the main suite vanity. We noted a leaky tub/shower valve at the guest suite bathroom (picture 17). We noted non-traditional use of plastic supply lines to the vanity sink fixtures at the basement bathroom and recommend metallic (picture 21).

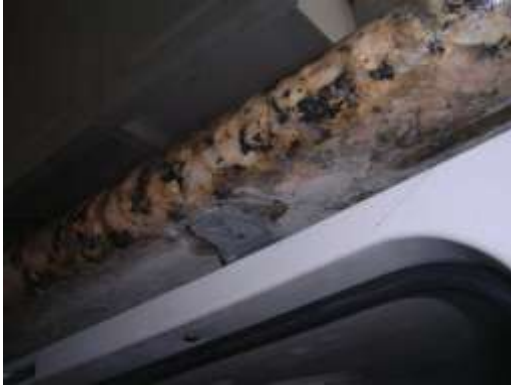
Picture 16

16. The dishwasher is not mechanically fastened to the underside of the countertop (picture 16).

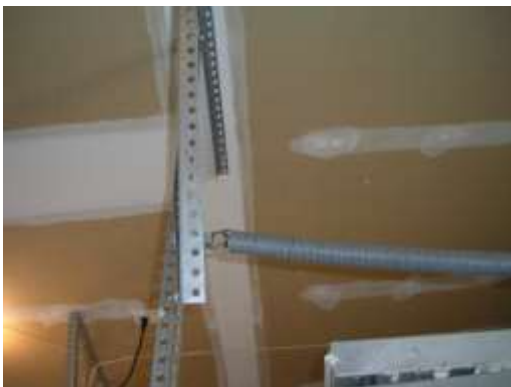
Picture 13

1. There is no safety cable at the coil spring mechanism servicing the smaller overhead garage door (picture 13). We recommend installation of same in the event of damage to the spring making it a projectile.

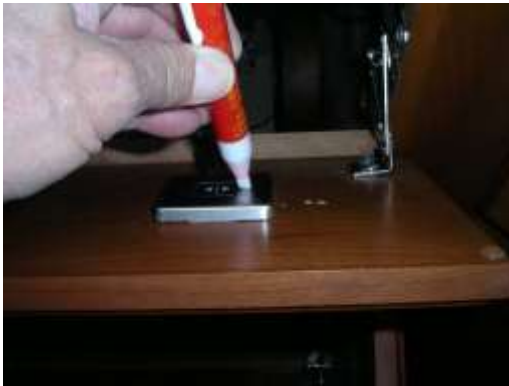
Picture 15

3. We attempted to engage the down draft fan at the cook top and was shocked when we touched the control panel at the sink front (picture 15). We recommend further review and repair as needed. After repairs, this system should be re-tested.

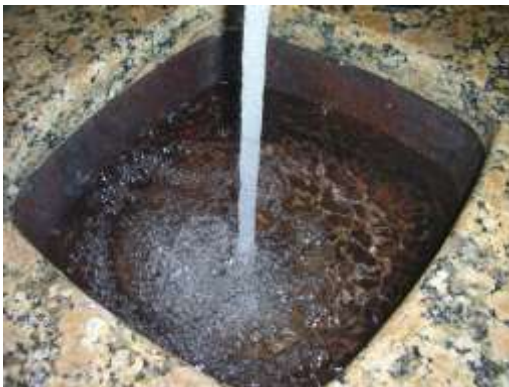
Picture 22

4. We noted that the sink at the basement kitchen/bar area did not drain properly. With water running consistently, the sink would fill, partially drain, then re-fill (picture 22). This may be the result of venting or drain issues. We recommend further review by a licensed plumbing contractor with repairs executed in a professional and workmanship like manner.

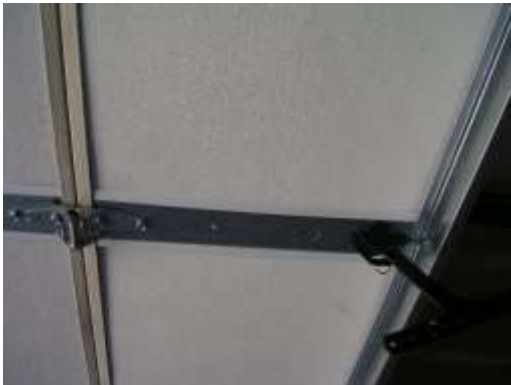
Picture 12

2. Please ensure that all below grade drain lines, both interior and exterior, are cleared routinely to ensure their integrity.
3. We were unable to identify the location of the water stop box.
4. As we discussed during our inspection, you may wish to consider the installation of a handrail at the rear landing and steps.
5. Please ensure that all open joints, cracks and seams that exist at present or develop over time at the walk and drive surfaces are sealed with an appropriate material on a routine basis to help minimize frost damage.
6. We noted lack of braces at the overhead garage doors for the installation of the electric openers (picture 12).

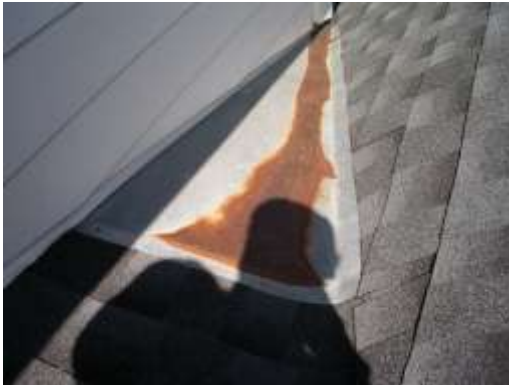
Picture 3

7. Please note that extensive storage within the garage prevented our complete and thorough review.
8. We identified some rust deterioration to the metal valley at the south exposure of the lower level roof (picture 3).

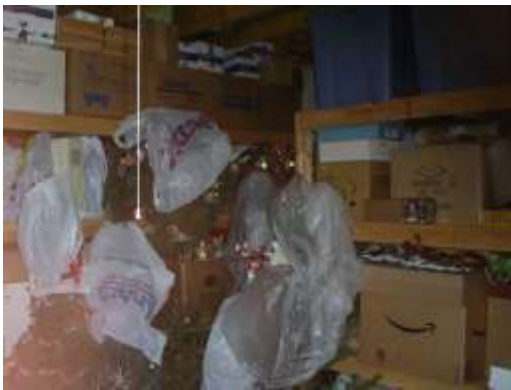
Picture 19

18. Based on the age of the water heaters, they have a moderate to high potential for replacement and we recommend close monitoring. Also based on its age, sediment build-up has likely occurred, which can compromise efficiency and the available amount of hot water.
19. Please note that approximately 85% of the basement has been finished; this and extensive storage did limit our review of the foundation and interior support members. We also noted extensive storage at the perimeter of the interior foundation walls, which greatly impaired our complete and thorough review (picture 19).

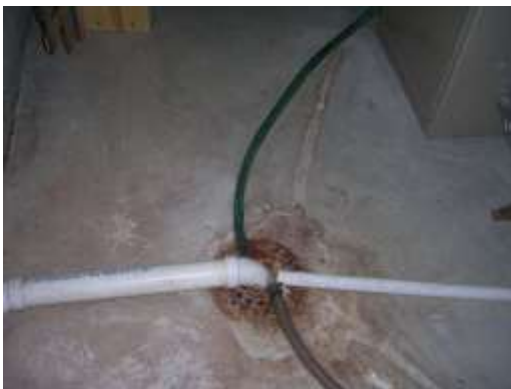
Picture 20

20. Access to the basement floor drain was blocked due to the temporary drain (picture 20).

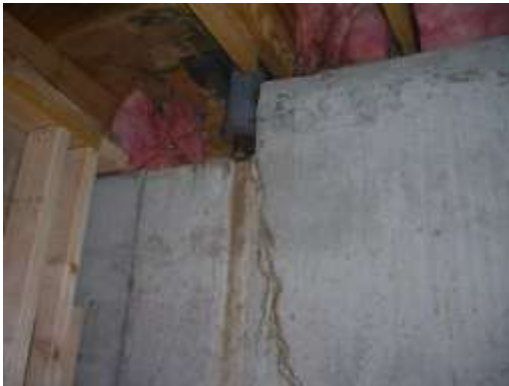
Picture 18

22. We identified some very small water stains at a dehydration crack at the west foundation wall, directly north of the sunken living space above (picture 18). There were no additional stains at the floor or below this location and we recommend close monitoring.
